Your Land Rovers

130 DEFENDER Td5 TIPPER

Rail-roaded

David Conroy's modified Defender 130 is rightly 'feared' by unwanted foliage besieging preserved railway lines up and down the country

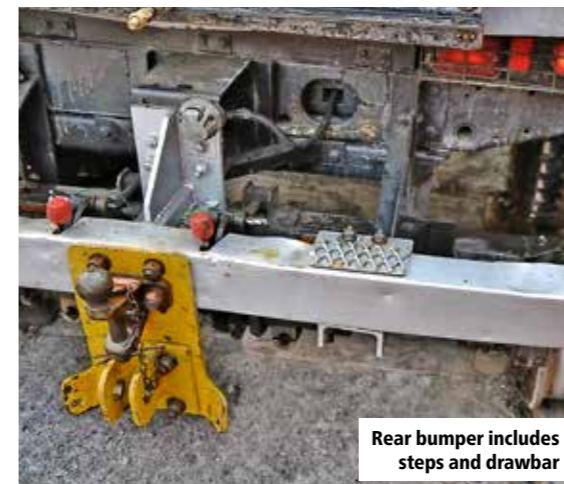
Rear bumper includes steps and drawbar

The two little 'flagpoles' mark the front corners of the Harsco rail gear. I've added sections of tread-plate to the bumpers front and rear to give extra grip when climbing aboard and I've mounted special brackets under the bumpers to help locate the farm jack when lifting – a useful safety idea, I think.

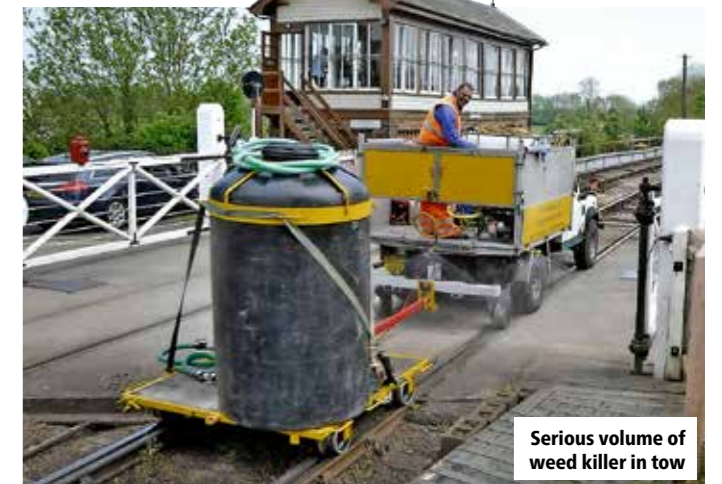
Serious volume of weed killer in tow

As you can see from the photos, my Defender is able to drive on the railway lines while towing a trailer carrying several thousand litres of water-based weed killer.

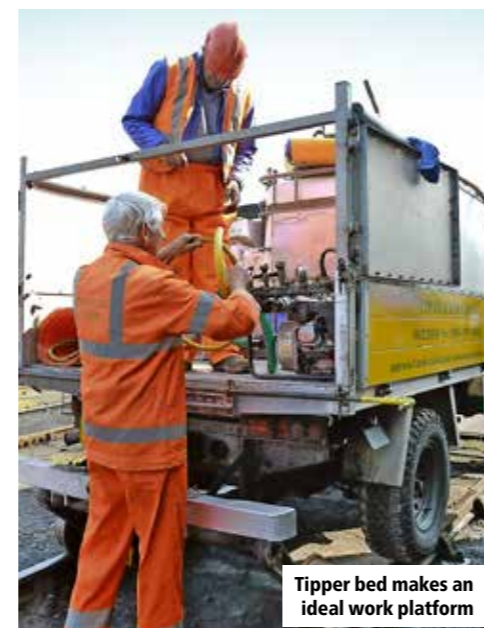
Tipper bed makes an ideal work platform

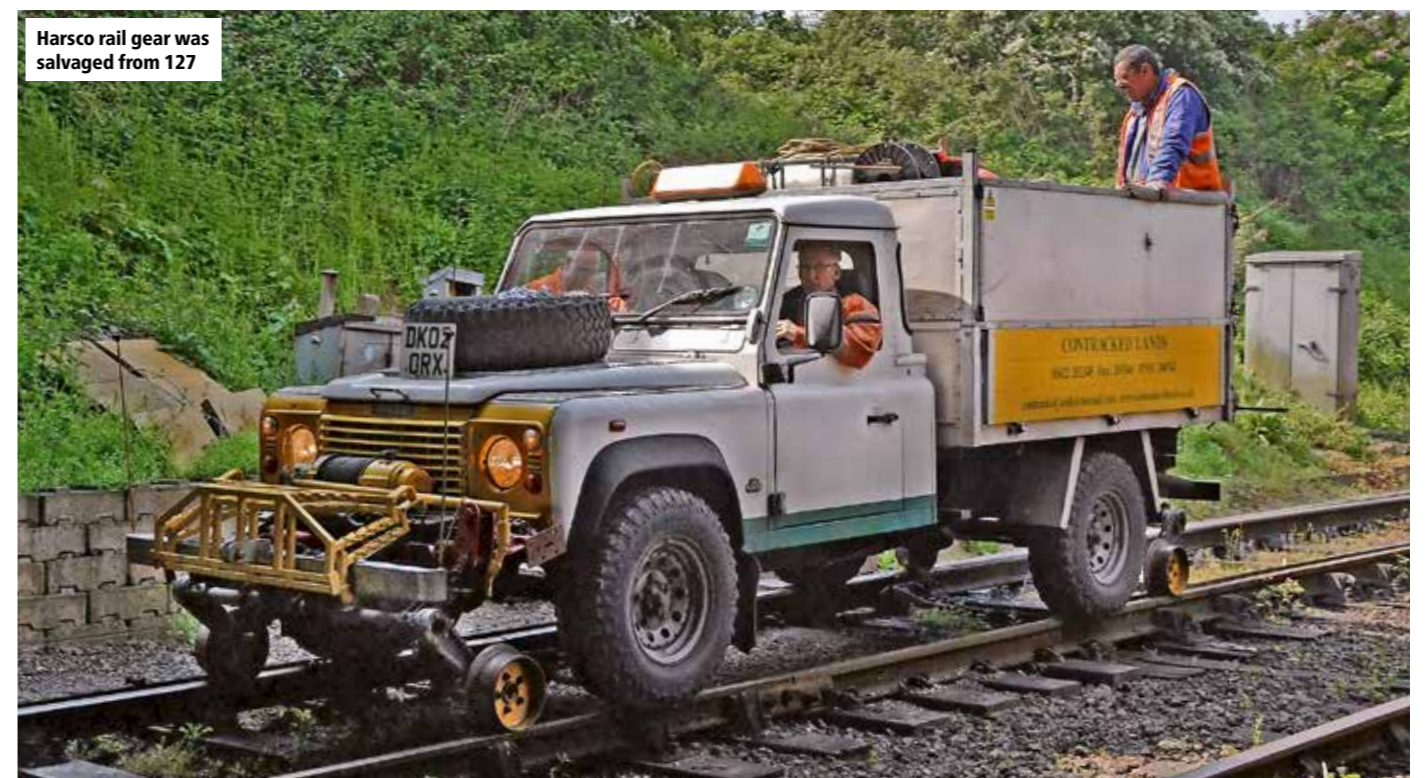
Harsco rail gear was salvaged from 127

Apart from fitting Harsco rail gear, I got the cab extended by 10in for improved legroom. To give more elbow room, I had the steering column and pedals moved inboard by three inches. I ditched the centre seat and replaced the two outer seats with a pair from a Mercedes.

Unfortunately, a hydraulic leak from the steering led to another fire, self-inflicted this time. However, I was able to salvage the Harsco rail gear and the big winch from the 127.

The current vehicle of choice is this Defender 130 crew cab. It's got Harsco rail gear which I manually engage – push ones have hydraulic power. The fact that it's a tipper is unimportant – it was the vehicle that was available at the right time, following the 127's destruction.
